**No.76 IACS Guidelines for Surveys, Assessment and
Repair of Hull Structure – Bulk Carriers**

BULK CARRIERS

**Guidelines for Surveys, Assessment and Repair of Hull
Structure**

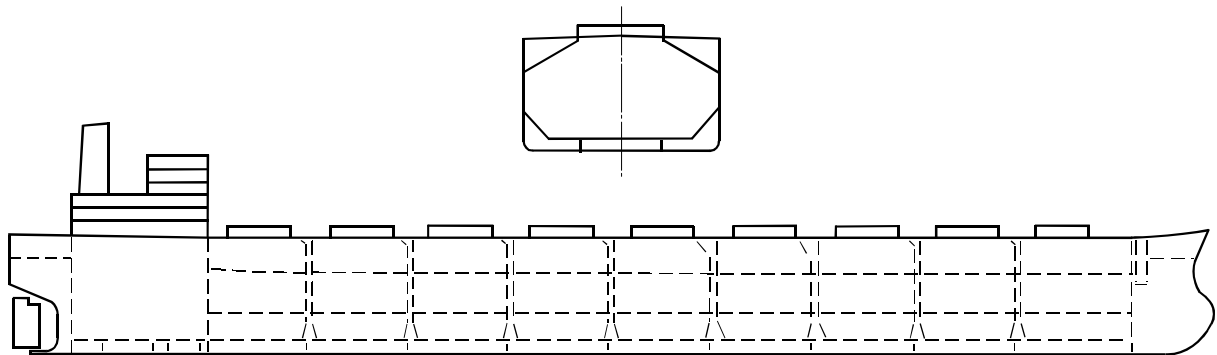
This manual gives guidelines for a bulk carrier type ship which is constructed with a single deck, single skin, double bottom, hopper side tanks and topside tanks in cargo spaces, and is intended primarily to carry dry cargo, including ore, in bulk. **Figure 1** shows the general view of a typical single skin bulk carrier with 9 cargo holds.

Figure 1 General view of a typical single skin bulk carrier

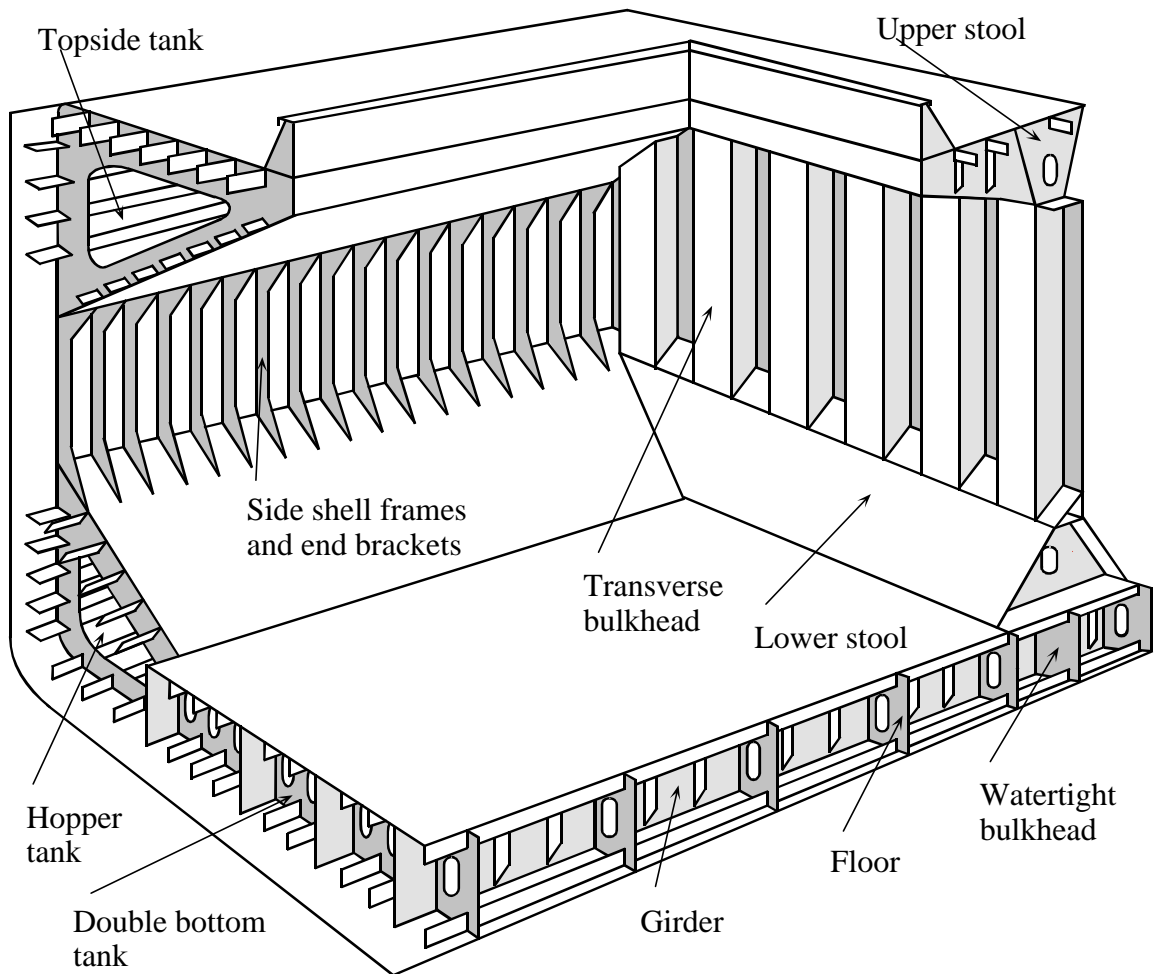
Figure 2 shows a typical cargo hold structural arrangement in way of cargo hold region.

Figure 2 Typical cargo hold configuration for a single skin bulk carrier

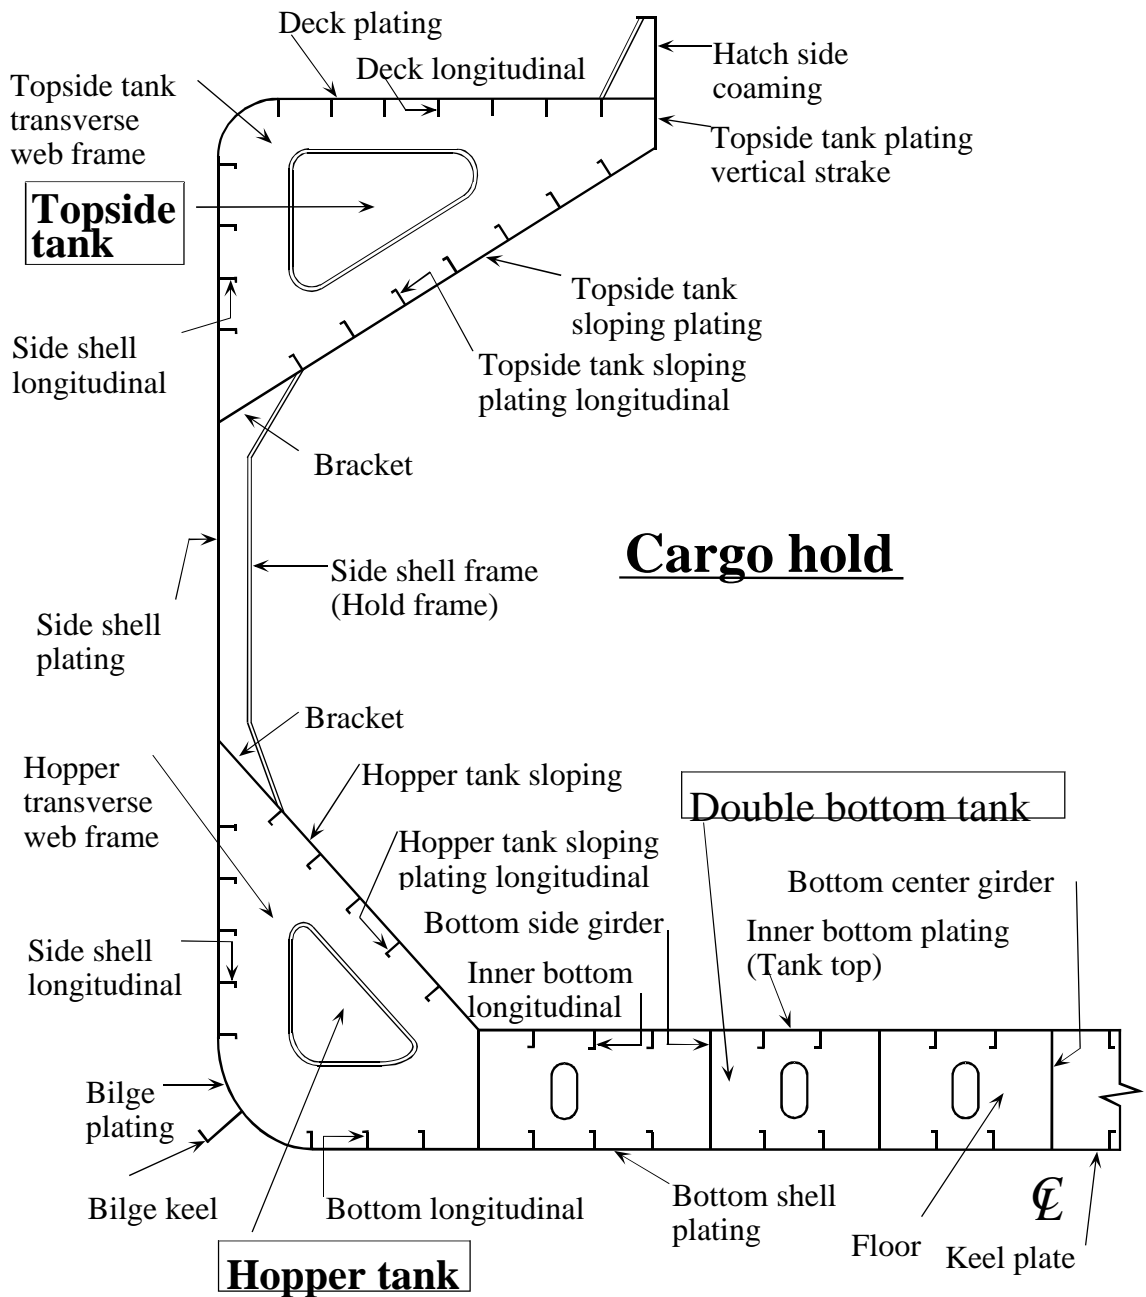
Figure 3 (a) Nomenclature for typical transverse section in way of cargo hold

3.2.1 For clarity of definition and reporting of survey data, it is recommended that standard nomenclature for structural elements be adopted. Typical sections in way of cargo holds are illustrated in **Figures 3 (a)** and **(b)**. These figures show the generally accepted nomenclature. The terms used in these guidelines are defined as follows.

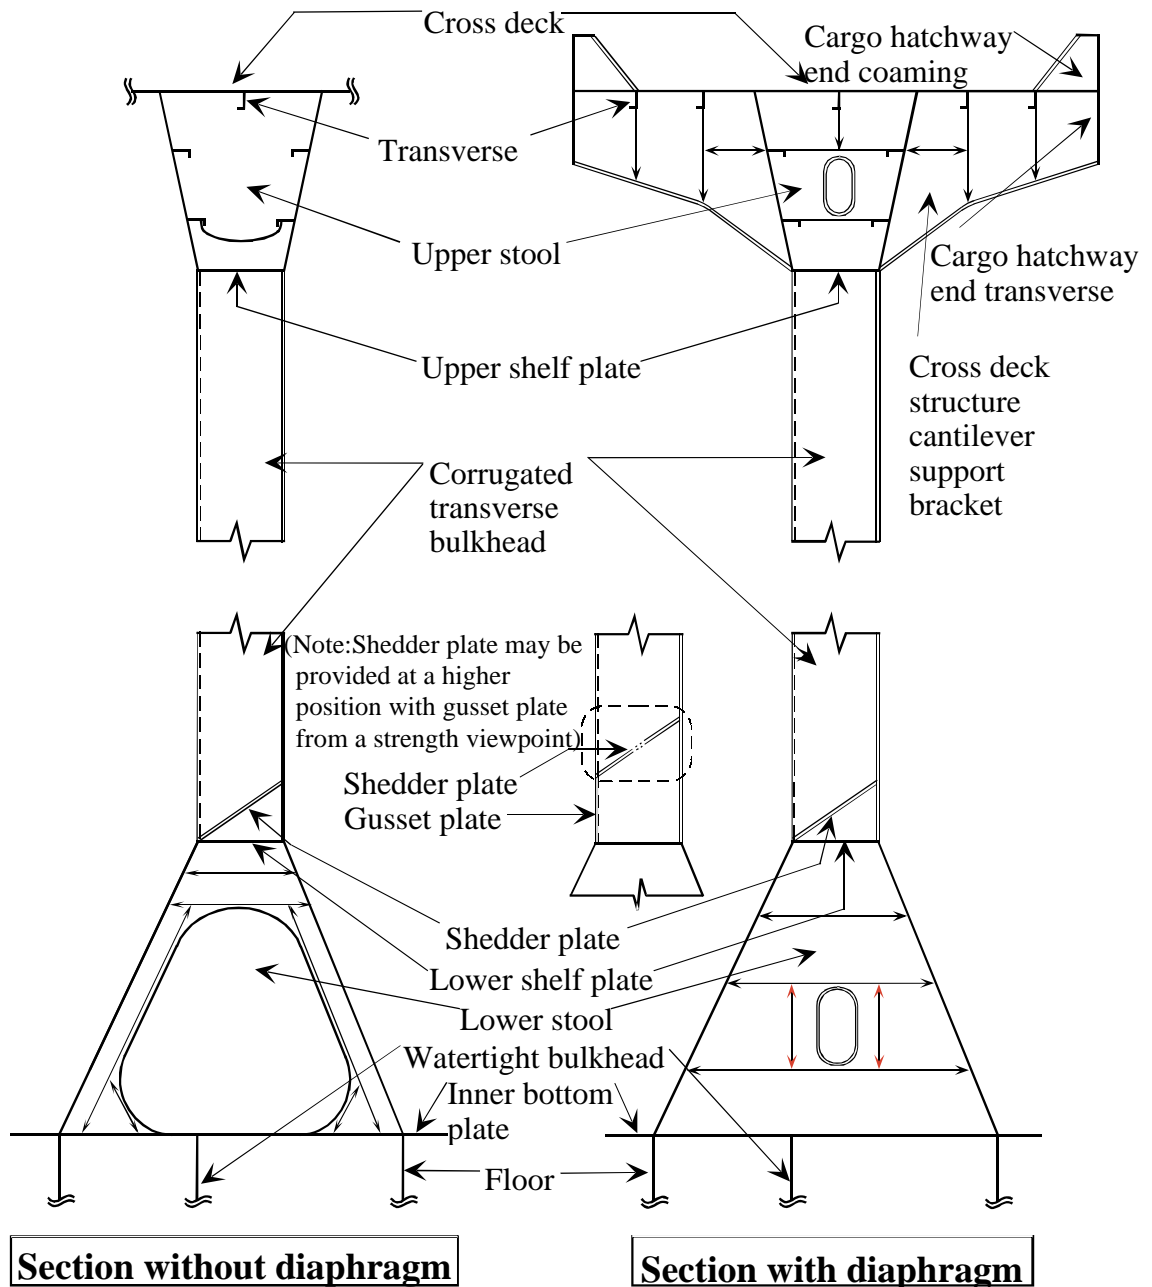
Figure 3 (b) Nomenclature for typical watertight bulkhead

- 1.3** The bulkheads are commonly constructed as vertically corrugated with a lower stool, and with or without an upper stool (See **Chapter 3 Technical background for surveys - Figure 3 (b)**). Other constructions may be:
Plane bulkhead plating with one sided vertical stiffeners.
Double plated bulkhead with internal stiffening, with or without stool(s).

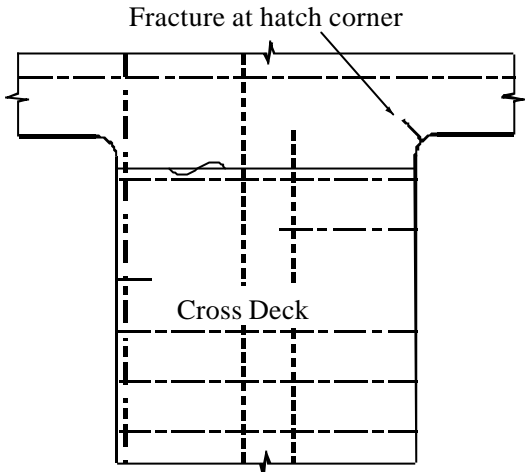
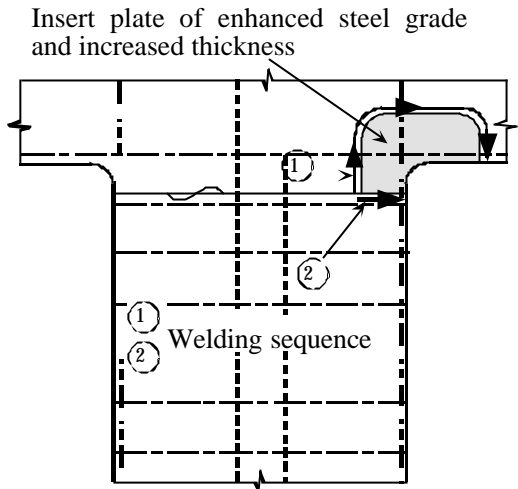
BULK CARRIERS		Guidelines for Surveys, Assessment and Repair of Hull Structure	
Part 1	Cargo hold region	Example No.	
Area 1	Deck structure	1	
Detail of damage		Fractures at main cargo hatch corner	
<p>Sketch of damage</p>

<p>Notes on possible cause of damage</p> <ol style="list-style-type: none"> 1. Stress concentration at hatch corners, i.e. radius of corner. 2. Welded attachment of shedder plate close to edge of hatch corner. 3. Wire rope groove. 		<p>Notes on repairs</p> <ol style="list-style-type: none"> 1. The corner plating in way of the fracture is to be cropped and renewed. If stress concentration is primary cause, insert plate should be increased thickness, enhanced steel grade and/or improved geometry. Insert plate should be continued beyond the longitudinal and transverse extent of the hatch corner radius ellipse or parabola, and the butt welds to the adjacent deck plating should be located well clear of the butts in the hatch coaming. It is recommended that the edges of the insert plate and the butt welds connecting the insert plates to the surrounding deck plating be made smooth by grinding. In this respect caution should be taken to ensure that the micro grooves of the grinding are parallel to the plate edge. 2. If the cause of fracture is welded attachment of shedder plate, the deck connection should be left unwelded. 3. If the cause of the fracture is wire rope groove, replacement to the original design can be accepted.

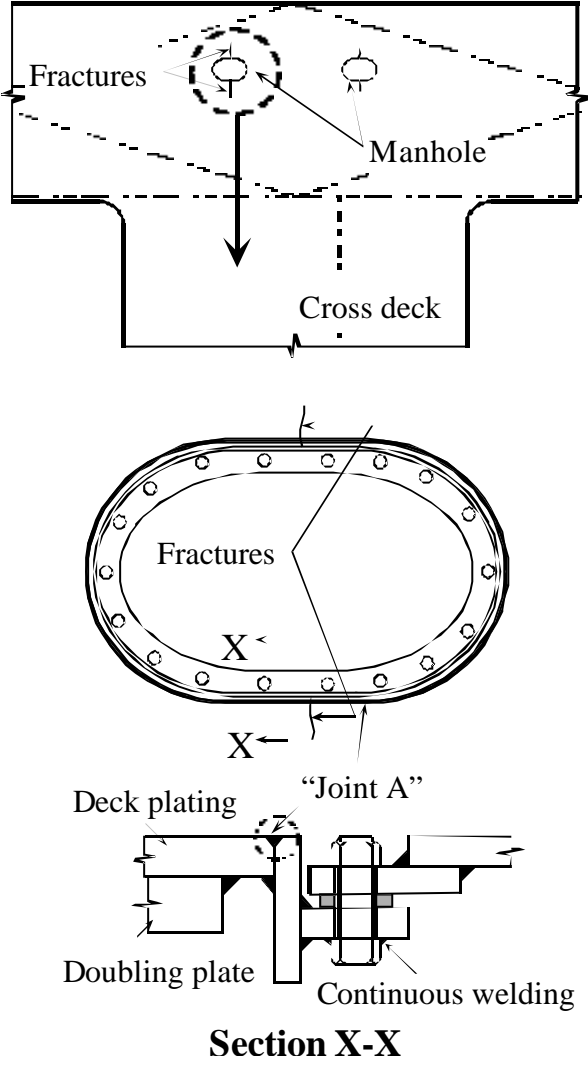
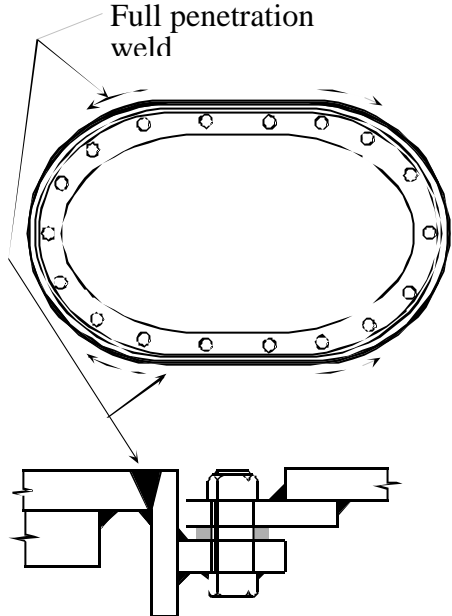
BULK CARRIERS		Guidelines for Surveys, Assessment and Repair of Hull Structure	
Part 1	Cargo hold region	Example No.	
Area 1	Deck structure	4	
Detail of damage		Fractures in deck plating initiated from weld of access manhole	
Sketch of damage		Sketch of repair

<p>The sketch of damage includes three parts: 1) A top-down view of a manhole on a deck showing fractures in the surrounding plating. 2) A circular plan view of the manhole with fractures along its perimeter. 3) A cross-section X-X of the manhole joint, showing the deck plating, a doubler plate, and continuous welding at 'Joint A'.</p>

<p>The sketch of repair includes two parts: 1) A top-down view of the manhole showing a full penetration weld around its perimeter. 2) A cross-section of the joint showing the full penetration of the weld between the deck plating and the doubler plate.</p>	
Notes on possible cause of damage		Notes on repairs

<ol style="list-style-type: none"> 1. Heavy weather. 2. Improper welding of joint "A". 		<ol style="list-style-type: none"> 1. The fracture in deck plating to be veed-out and rewelded, or deck plating cropped and part renewed if considered necessary. 2. Full penetration of joint "A" should be considered.

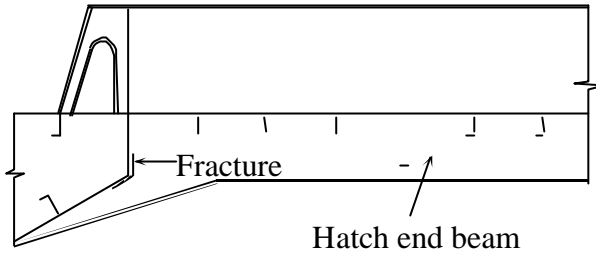
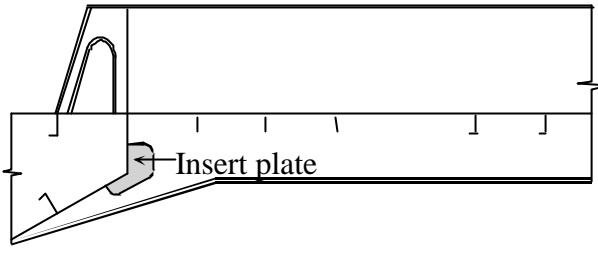
BULK CARRIERS		Guidelines for Surveys, Assessment and Repair of Hull Structure	
Part 1	Cargo hold region	Example No.	
Area 1	Deck structure	8	
Detail of damage		Fractures in hatch end beam at the joint to topside tank	
Sketch of damage		Sketch of repair

Notes on possible cause of damage		Notes on repairs	
<ol style="list-style-type: none"> Misalignment of the hatch end beam with transverse web frame in topside tank. Stress concentration. 		<ol style="list-style-type: none"> Fractured part to be cropped and renewed.

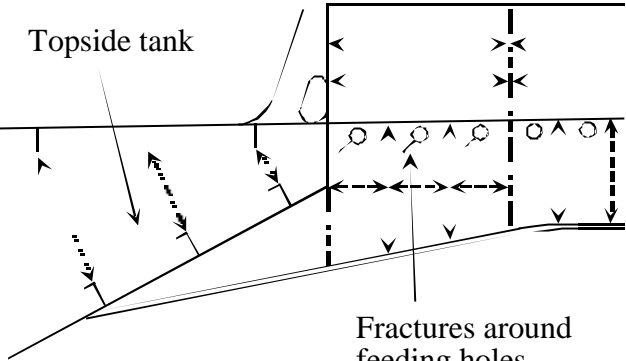
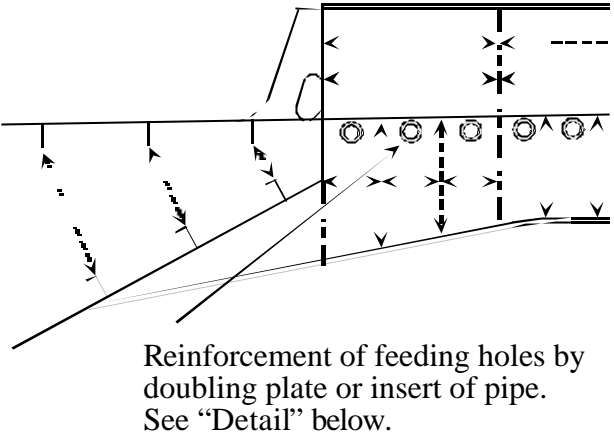
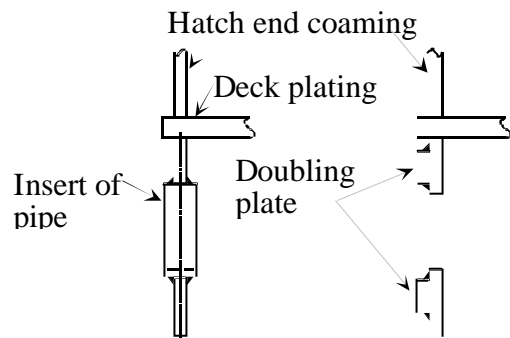
BULK CARRIERS		Guidelines for Surveys, Assessment and Repair of Hull Structure	
Part 1	Cargo hold region	Example No.	
Area 1	Deck structure	9	
Detail of damage		Fractures in hatch end beam around feeding holes	
Sketch of damage		Sketch of repair

<p>Topside tank</p> <p>Fractures around feeding holes</p>

<p>Reinforcement of feeding holes by doubling plate or insert of pipe. See "Detail" below.</p>

<p>Hatch end coaming</p> <p>Deck plating</p> <p>Insert of pipe</p> <p>Doubling plate</p> <p>Detail</p>	
Notes on possible cause of damage		Notes on repairs	
<ol style="list-style-type: none"> 1. Inadequate reinforcement around feeding hole. 2. Corrosion. 		<ol style="list-style-type: none"> 1. Fractured part to be veed-out or cropped and renewed. 2. If the fractured part is free from corrosion, reinforcement should be considered.

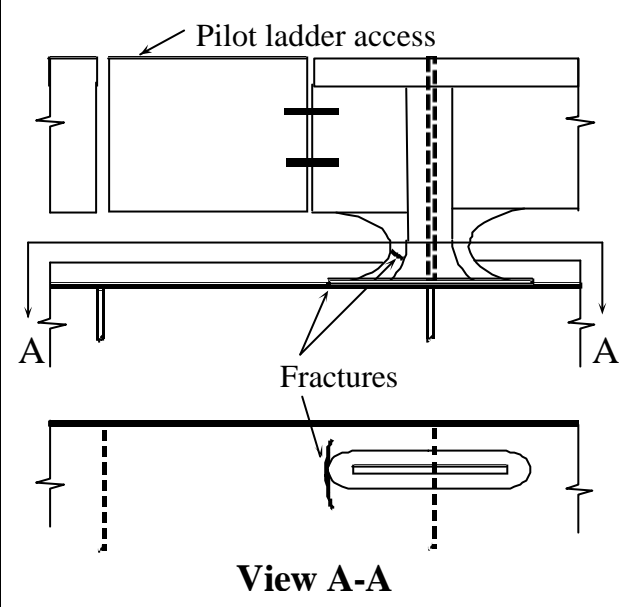
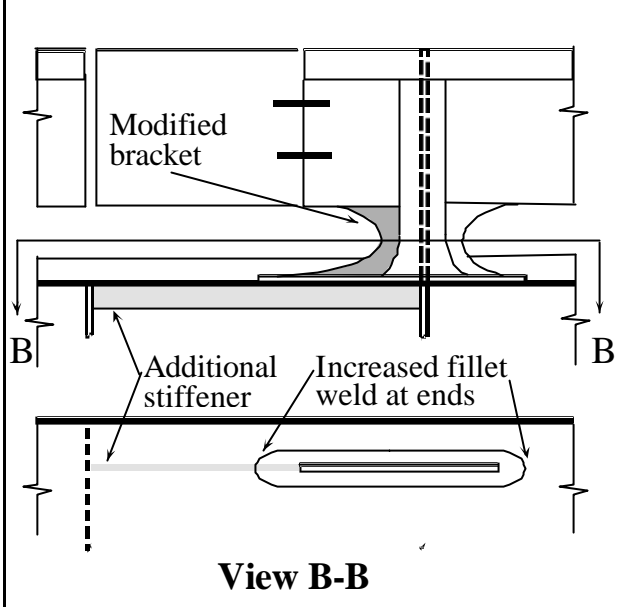
BULK CARRIERS		Guidelines for Surveys, Assessment and Repair of Hull Structure	
Part 1	Cargo hold region	Example No.	
Area 1	Deck structure	12	
Detail of damage		Fractures in deck plating at the pilot ladder access of bulwarks	
Sketch of damage

Notes on possible cause of damage 1. Stress concentration at the termination of bulwarks.		Notes on repairs 1. Fractured deck plating should be cropped and part renewed. 2. Reduction of stress concentration should be considered. In the above figure gusset plate was replaced with soft type for the fracture in gusset plate and pad plate was increased. Additional stiffeners were provided for the fracture in deck plating.

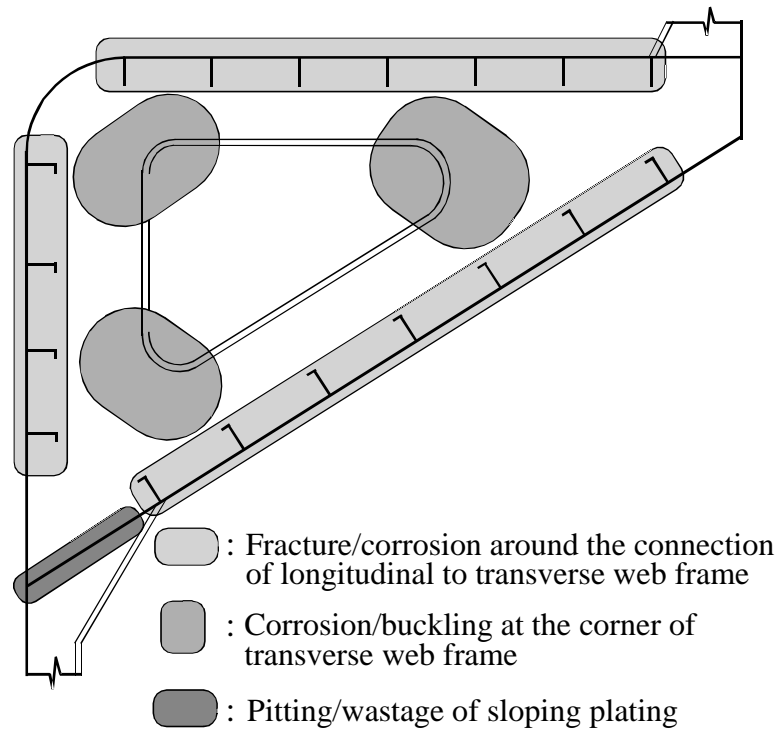
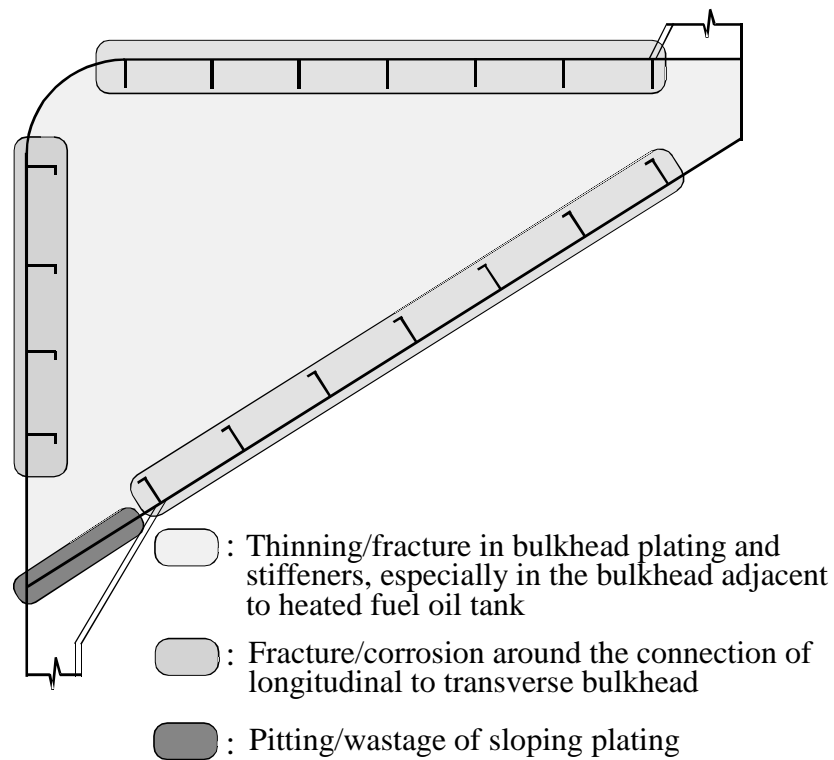
(a) Transverse web frame section

(b) Transverse bulkhead section

Figure 1 Topside tank - Potential problem areas

2.1.2 Rate and extent of corrosion depends on the environmental conditions, and protective measures employed, such as coatings and sacrificial anodes. The following structures are generally susceptible to corrosion (See **Figure 1**).

- (a) Structure in corrosive environment
 - Deck plating and deck longitudinal
 - Transverse bulkhead adjacent to heated fuel oil tank
 - Lowest part of sloping plating
- (b) Structure subject to high stress
 - Face plates and web plates of transverse at corners
 - Connection of side longitudinal to transverse
- (c) Areas susceptible to coating breakdown
 - Back side of face plate of longitudinal
 - Welded joint
 - Edge of access opening
- (d) Areas subjected to poor drainage
 - Web of side and sloping longitudinals

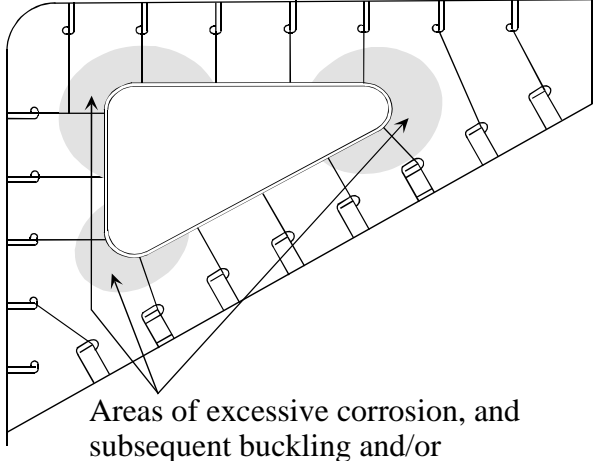
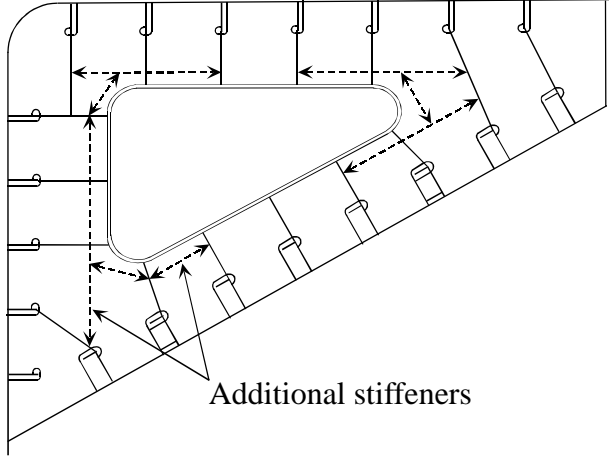
BULK CARRIERS		Guidelines for Surveys, Assessment and Repair of Hull Structure	
Part 1	Cargo hold region	Example No.	
Area 2	Topside tank structure	2-a	
Detail of damage	Thinning and subsequent buckling of web plating in the vicinity of the radii of the opening		
Sketch of damage		Sketch of repair

<p>Areas of excessive corrosion, and subsequent buckling and/or</p>

<p>Additional stiffeners</p>	
Notes on possible cause of damage		Notes on repairs	
<ol style="list-style-type: none"> 1. Insufficient buckling strength. 2. Corrosion due to stress concentration at corners. 		<ol style="list-style-type: none"> 1. Buckled plating is to be cropped and parts renewed, if necessary. 2. Additional stiffeners as shown above and/or renewal with plating of increased thickness should be considered.

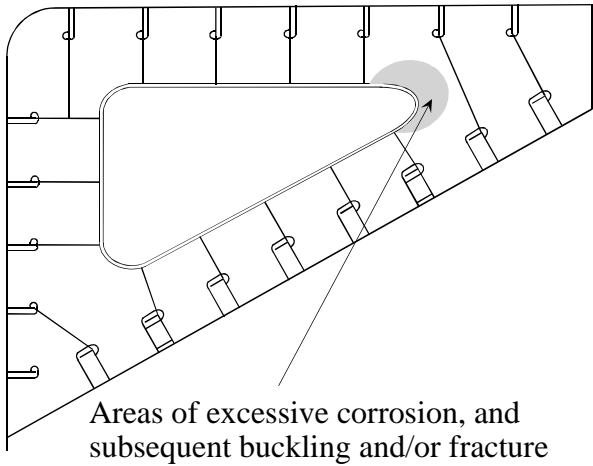
BULK CARRIERS		Guidelines for Surveys, Assessment and Repair of Hull Structure	
Part 1	Cargo hold region	Example No.	
Area 2	Topside tank structure	2-b	
Detail of damage	Thinning and subsequent buckling of web plating in the vicinity of the radii of the opening		
Sketch of damage		Sketch of repair

<p>Areas of excessive corrosion, and subsequent buckling and/or fracture</p>

<p>Enlarged radius of the opening</p>	
Notes on possible cause of damage		Notes on repairs	
<ol style="list-style-type: none"> 1. Corrosion caused by stress concentration at the corner due to insufficient radius for the opening. 		<ol style="list-style-type: none"> 1. Corroded/buckled plating is to be cropped and parts renewed with plating of increased thickness and additional stiffeners are preferable to minimize deflection. 2. An attempt should be made to improve the design of the radius if felt necessary.

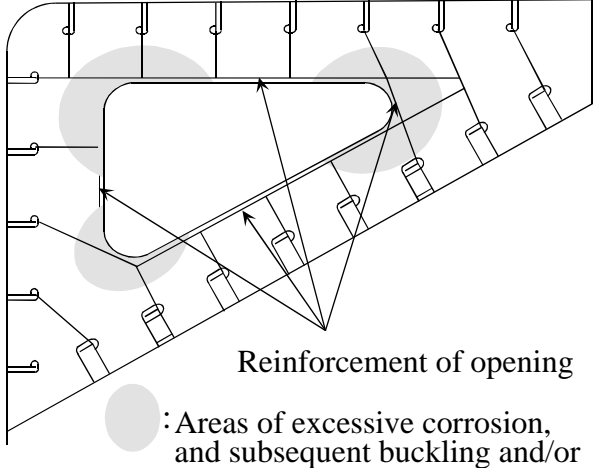
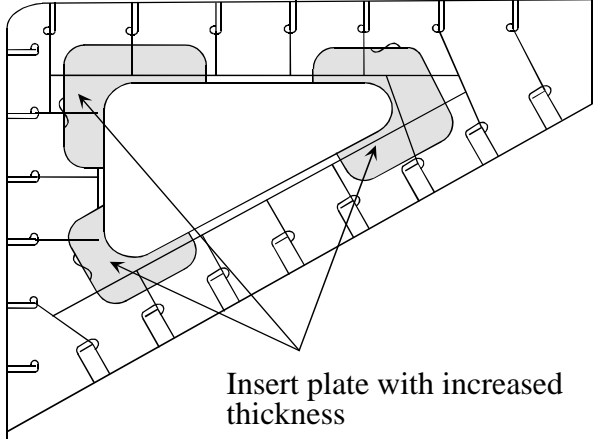
BULK CARRIERS		Guidelines for Surveys, Assessment and Repair of Hull Structure	
Part 1	Cargo hold region	Example No.	
Area 2	Topside tank structure	2-c	
Detail of damage	Thinning and subsequent buckling of web plating in the vicinity of the radii of the opening		
Sketch of damage		Sketch of repair

<p>Reinforcement of opening</p> <p>: Areas of excessive corrosion, and subsequent buckling and/or</p>

<p>Insert plate with increased thickness</p>	
Notes on possible cause of damage		Notes on repairs	
<p>1. Additional stresses at the free edge of transverse web. (In Example 2-a - 2-c face plate is provided for the reinforcement of the opening.)</p>		<p>1. Corroded/buckled plating is to be cropped and part renewed with plating of increased thickness.</p>

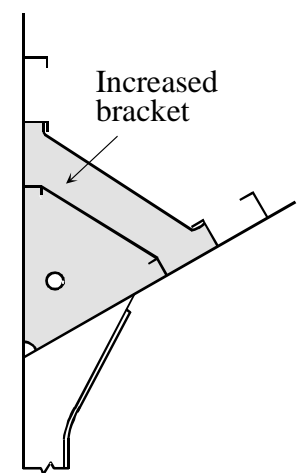
<p>The sketch shows a longitudinal beam supported by a bracket. A fracture is indicated at the connection point. A detail view shows the fracture in the longitudinal beam. Labels include 'Longitudinals supported by bracket', 'See Detail', 'Longitudinal', and 'Fracture'.</p>	
Notes on possible cause of damage		Notes on repairs	
<p>1. Insufficient scantling for torsional rigidity (The lowest longitudinal is usually supported by bracket(s) as shown in the above and smaller scantling may be adopted. However, the lowest longitudinal undergoes torsion from side shell frame through bracket(s) and may suffer fracture.)</p>		<p>1. Fractured part to be cropped and renewed. 2. Size of bracket should be increased</p>

<p>The sketch shows an 'Increased bracket' supporting the longitudinal beam.</p>

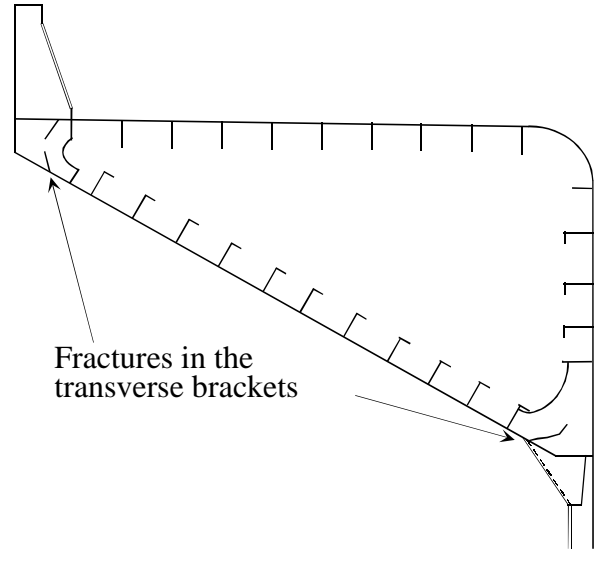
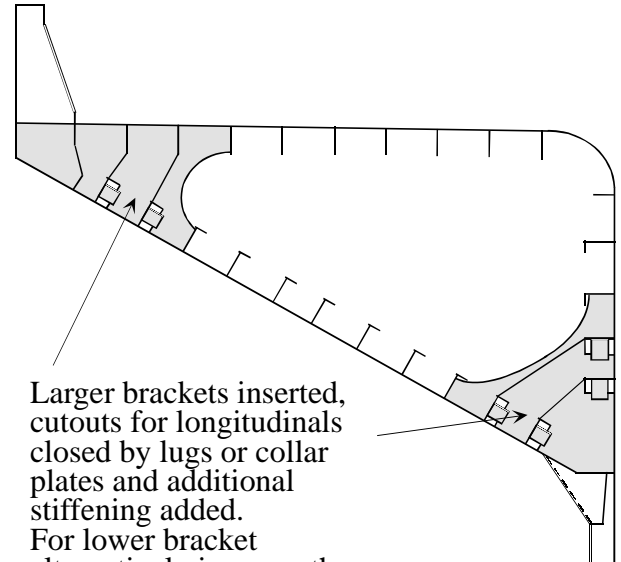
BULK CARRIERS		Guidelines for Surveys, Assessment and Repair of Hull Structure	
Part 1	Cargo hold region	Example No.	
Area 2	Topside tank structure	7-a	
Detail of damage		Fractures in transverse brackets	
Sketch of damage		Sketch of repair

<p>Fractures in the transverse brackets</p>

<p>Larger brackets inserted, cutouts for longitudinals closed by lugs or collar plates and additional stiffening added. For lower bracket alternatively increase the thickness</p>	
Notes on possible cause of damage		Notes on repairs	
<ol style="list-style-type: none"> 1. General levels of corrosion and presence of stress concentrations. 2. Misalignment of the brackets with adjoining structure, e.g. side shell frame brackets and/or coaming brackets. 3. High shear stresses due to insufficient bracket size. 4. Inadvertent overloading. 		<ol style="list-style-type: none"> 1. If the damage is caused by misalignment with the side shell frame brackets or the hatch coaming brackets the misalignment is to be rectified and the replacement by larger brackets incorporated only if considered necessary.

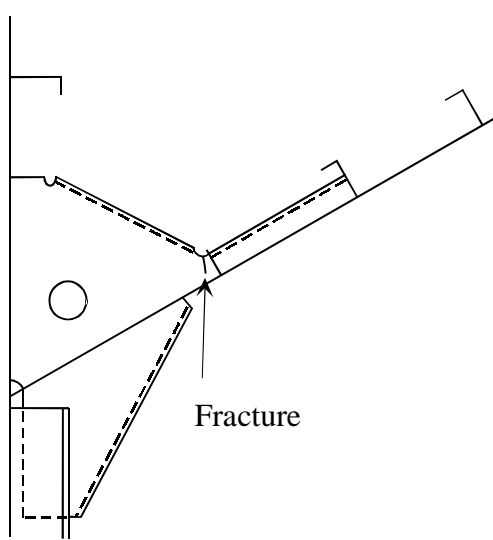
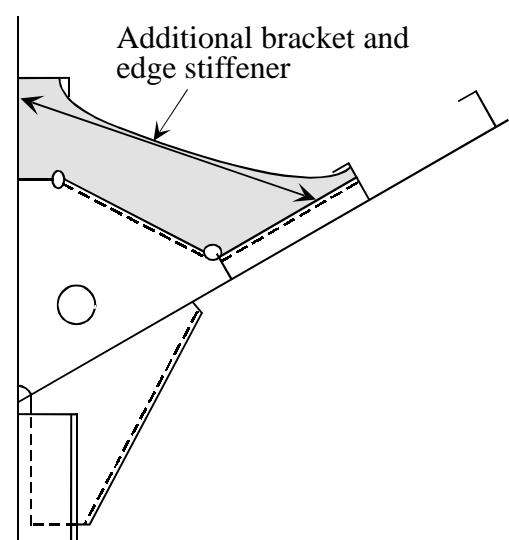
BULK CARRIERS		Guidelines for Surveys, Assessment and Repair of Hull Structure	
Part 1	Cargo hold region	Example No.	
Area 2	Topside tank structure	7-c	
Detail of damage		Fractures at toes of transverse bracket	
Sketch of damage		Sketch of repair

Notes on possible cause of damage		Notes on repairs	
<p>1. Stress concentration due to the shape of the bracket.</p>		<p>1. Cracked weld to be veed-out and rewelded.</p>

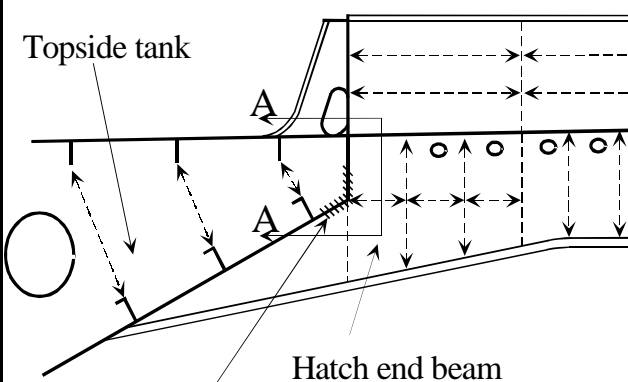
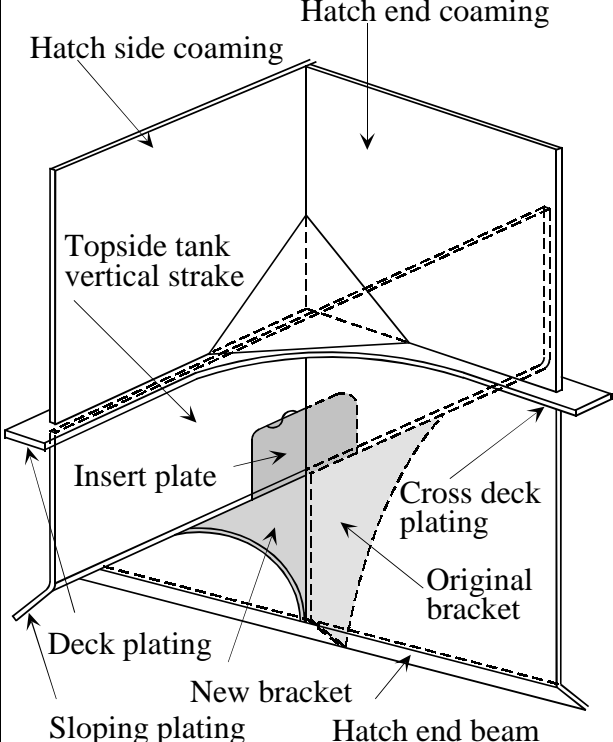
BULK CARRIERS		Guidelines for Surveys, Assessment and Repair of Hull Structure	
Part 1	Cargo hold region	Example No. 8	
Area 2	Topside tank structure		
Detail of damage	Fractures in sloping plating and vertical strake initiated from the connection of topside tank to hatch end beam		
Sketch of damage		Sketch of repair

<p>Topside tank</p> <p>Hatch end beam</p> <p>Fracture in sloping plating and vertical strake initiated from the connection of topside tank to hatch end beam</p> <p>Topside tank vertical strake</p> <p>Deck plating</p> <p>Fracture</p> <p>Hatch end beam</p> <p>Topside tank knuckle line</p> <p>Original bracket (See "Sketch of repair")</p> <p>View A-A</p>

<p>Hatch side coaming</p> <p>Hatch end coaming</p> <p>Topside tank vertical strake</p> <p>Insert plate</p> <p>Cross deck plating</p> <p>Original bracket</p> <p>Deck plating</p> <p>Sloping plating</p> <p>New bracket</p> <p>Hatch end beam</p>

Notes on possible cause of damage		Notes on repairs	
<ol style="list-style-type: none"> 1. Stress concentration at the connection of hatch end beam to topside tank. 		<ol style="list-style-type: none"> 1. Fractured part to be cropped and renewed with increased thickness. 2. Additional bracket should be considered for reinforcement.

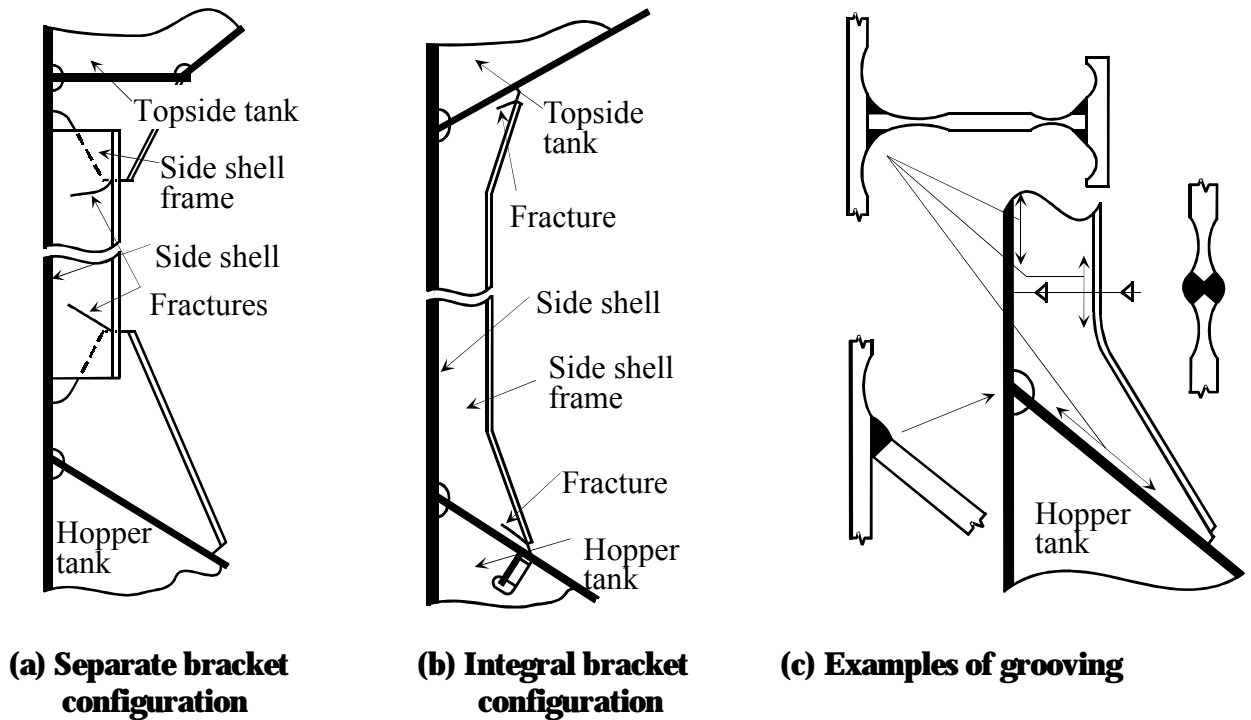
Figure 2 Damages to side shell frame - Potential problem areas

(Note) The type of bracket configuration used will, to a large extent, dictate the location and extent of fracture. Where separate brackets are employed, the fracture location is normally at the bracket toe position on the frames, whereas with integral brackets the location is at the toe position on the hopper and topside tank.

- 1.6** A summary of potential problem areas is shown in **Figures 1 - 4**. Examples of failure and damaged ship side structure are illustrated in **Photographs 1- 2**.

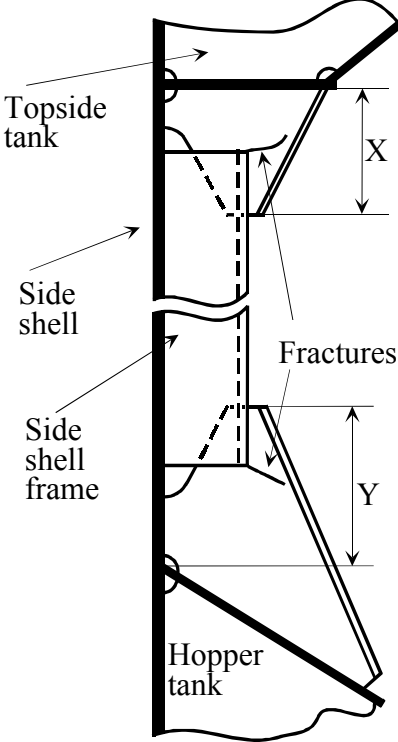
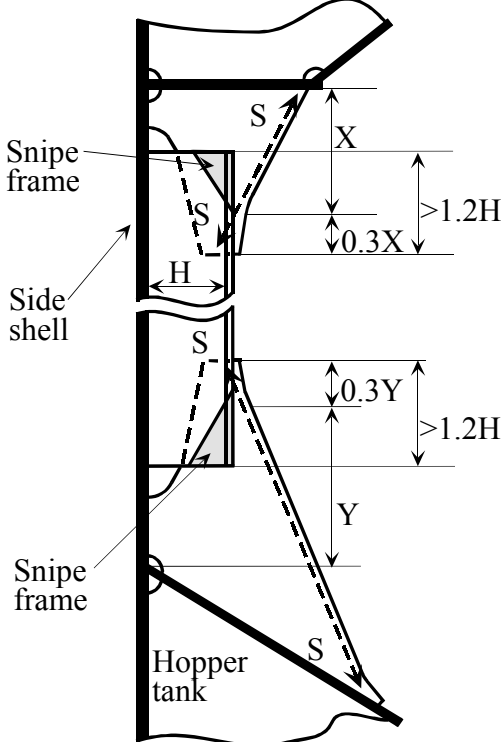
BULK CARRIERS		Guidelines for Surveys, Assessment and Repair of Hull Structure	
Part 1	Cargo hold region	Example No.	
Area 3	Cargo hold side structure	1-a	
Detail of damage		Fractures in brackets at termination of frame	
Sketch of damage		Sketch of repair

<p>Topside tank</p> <p>Side shell</p> <p>Side shell frame</p> <p>Fractures</p> <p>Hopper tank</p> <p>X</p> <p>Y</p> <p>Separate bracket configuration</p>

<p>Snipe frame</p> <p>Side shell</p> <p>Side shell frame</p> <p>Snipe frame</p> <p>Hopper tank</p> <p>X</p> <p>Y</p> <p>H</p> <p>0.3X</p> <p>1.2H</p> <p>0.3Y</p> <p>1.2H</p> <p>S</p> <p>S</p> <p>S</p> <p>S</p> <p>S=Snipped end</p>	
Notes on possible cause of damage		Notes on repairs	
<ol style="list-style-type: none"> 1. This type of damage is caused due to stress concentration. 		<ol style="list-style-type: none"> 1. For small fractures, e. g. hairline fractures, the fracture can be veed-out, ground, examined by NDT for fractures, and rewelded. 2. For larger/significant fractures consideration is to be given to cropping and partly renewing/ renewing the frame brackets. If renewing the brackets, end of frames can be sniped to soften them. 3. If felt prudent, soft toes are to be incorporated at the boundaries of the bracket to the hopper plating. 4. Attention to be given to the structure in wing tanks in way of the extended bracket arm. i.e. reinforcement provided in line with the bracket.

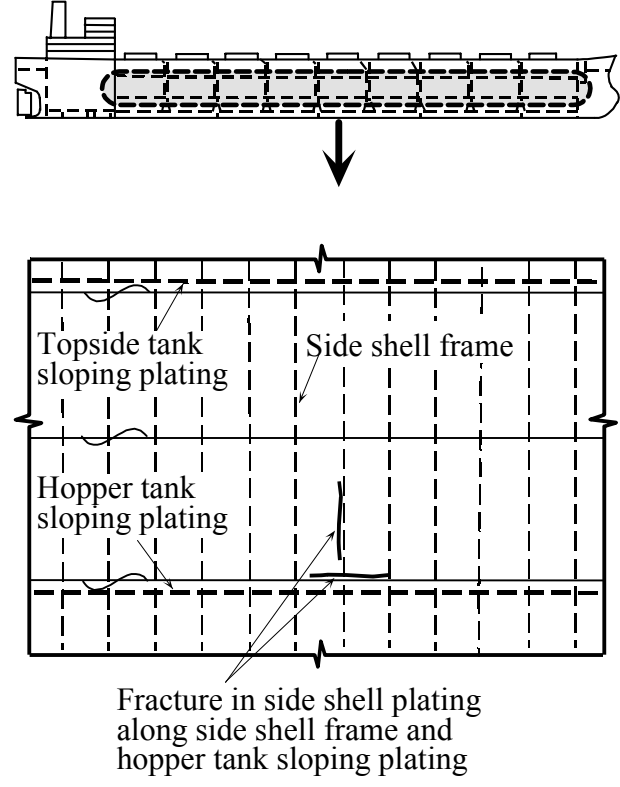
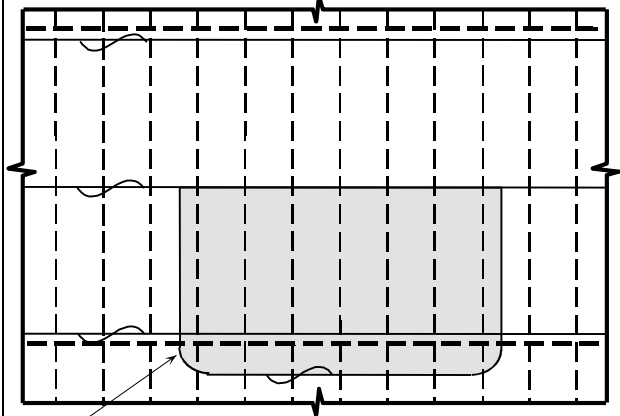
BULK CARRIERS		Guidelines for Surveys, Assessment and Repair of Hull Structure	
Part 1	Cargo hold region		Example No.
Area 3	Cargo hold side structure		3
Detail of damage		Fractures in side shell frame/lower bracket and side shell plating near hopper	
Sketch of damage		Sketch of repair

<p>Fracture in side shell plating along side shell frame and hopper tank sloping plating</p>

<p>Part renewal including side shell frames and hopper sloping plating, as found necessary</p>	
Notes on possible cause of damage		Notes on repairs	
<ol style="list-style-type: none"> 1. Heavy corrosion (grooving). Refer to Figure 2 (c). 		<ol style="list-style-type: none"> 1. Sketch of repair applies when damage extends over several frames. 2. Isolated fractures may be repaired by veeing-out and rewelding. 3. Isolated cases of grooving may be repaired by build up of welding.

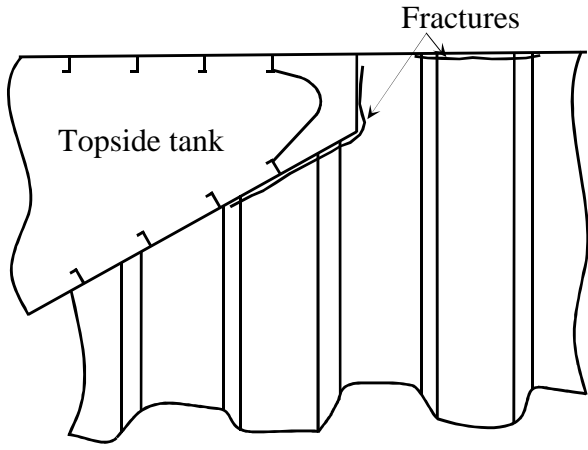
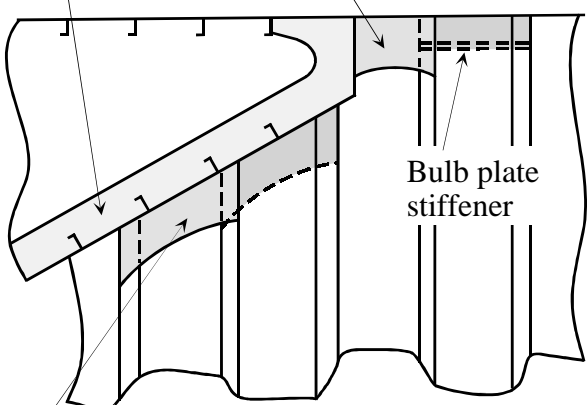
BULK CARRIERS		Guidelines for Surveys, Assessment and Repair of Hull Structure	
Part 1	Cargo hold region	Example No.	
Area 4	Transverse bulkhead and associated structure in cargo hold	2	
Detail of damage		Fractures at the upper boundaries to topside tanks	
Sketch of damage		Sketch of repair

<p>The sketch shows a cross-section of a hull structure. On the left, a curved structure is labeled 'Topside tank'. To its right, several vertical stiffeners are shown. At the top of these stiffeners, there are jagged lines indicating 'Fractures' at the upper boundaries where they meet the topside tank.</p>		<p>Continuous or intercostal reinforcement in line with flanges or gussets where not already fitted</p> <p>Adjacent to the topside tank either a gusset to a bulb plate stiffener may be</p>

<p>The repair sketch shows the same structure as the damage sketch but with additional reinforcement. A shaded area represents 'Continuous or intercostal reinforcement' along the top edge of the stiffeners. A 'Gusset' is shown connecting the topside tank to a 'Bulb plate stiffener'. A note indicates 'Gusset(similar gusset on the opposite)'. The label 'Bulb plate stiffener' points to the vertical stiffener on the right.</p>

Notes on possible cause of damage		Notes on repairs	
<ol style="list-style-type: none"> 1. Damage due to poor design and/or defective welds. 		<ol style="list-style-type: none"> 1. Fractures may be veed-out and rewelded. If necessary corrugated plating cropped and renewed. 2. It is recommended that reinforcement as shown above be incorporated, giving due consideration to the following criteria: <ol style="list-style-type: none"> 2.1 It is important to have the gusset plates well aligned with the transverse structure inside the tank. Gusset plates may be joggled to obtain this alignment. 2.2 If there is no transverse web already existing inside the topside tank and in line with the flanges of corrugation or gusset plates, reinforcement as shown above to be fitted.

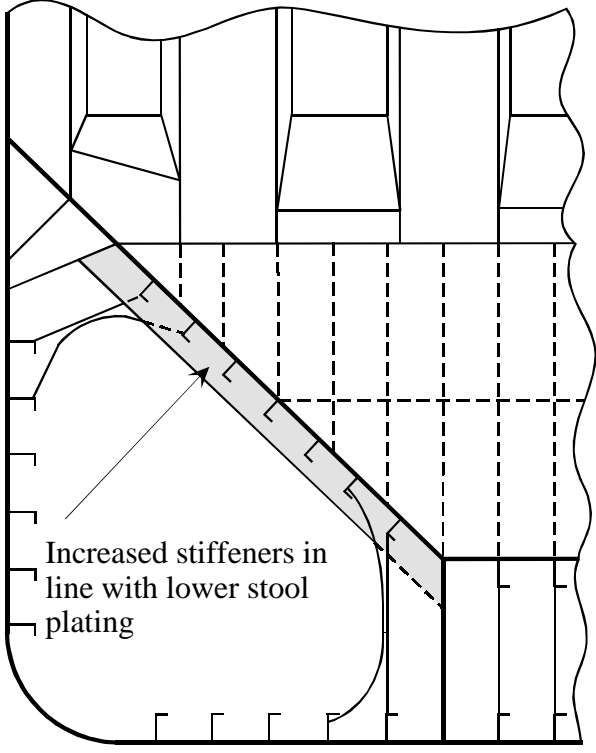
<p>Increased stiffeners in line with lower stool plating</p>	
Notes on possible cause of damage		Notes on repairs	
<ol style="list-style-type: none"> 1. Insufficient strength of the connection 2. Corrosion 		<ol style="list-style-type: none"> 1. Fractured stool plating should be partly cropped and renewed (thicker plate) if considered necessary. 2. If the damage occurred due to insufficient strength, stiffeners in line with stool plating should be increased.

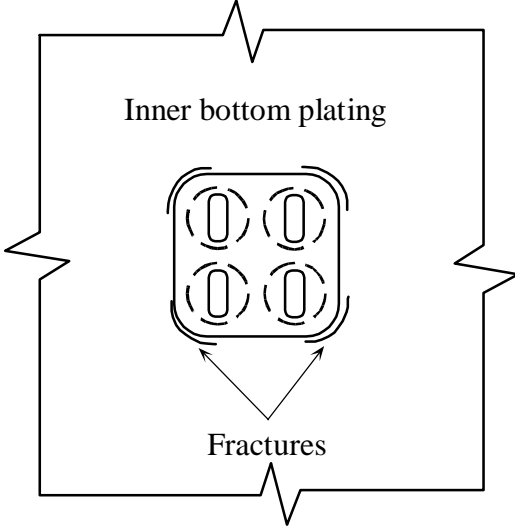
BULK CARRIERS		Guidelines for Surveys, Assessment and Repair of Hull Structure	
Part 1	Cargo hold region	Example No. 1	
Area 5	Double bottom structure including hopper	1	
Detail of damage		Fractures in inner bottom plating around container bottom pocket	
<p>Sketch of damage</p>

<p>Sketch of repair</p> <p>Most common repair</p>

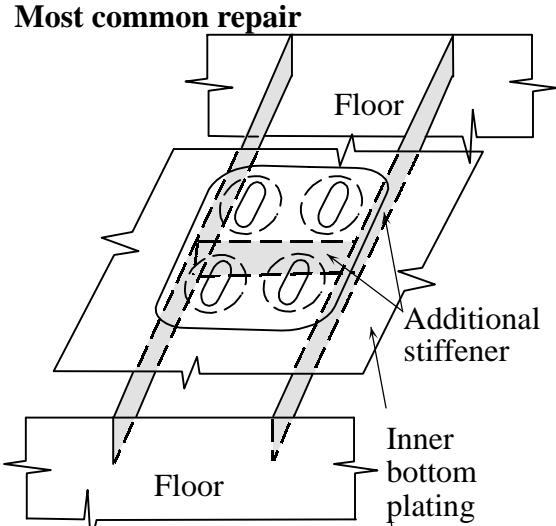
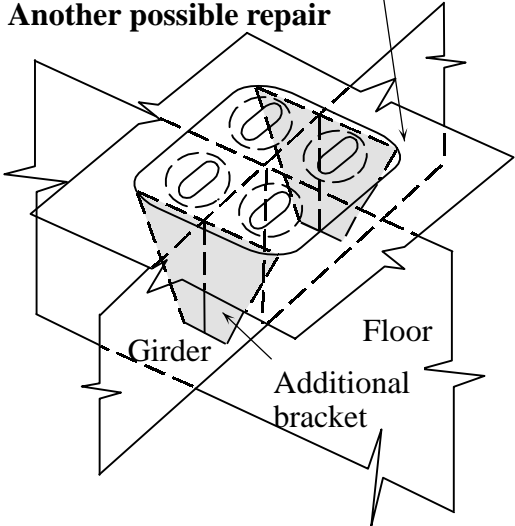
<p>Another possible repair</p>

<p>Notes on possible cause of damage</p> <ol style="list-style-type: none"> 1. Pocket is not supported correctly by floor, longitudinal and/or stiffener. 		<p>Notes on repairs</p> <ol style="list-style-type: none"> 1. Fractured plating should be cropped and part renewed. 2. Adequate reinforcement should be considered.

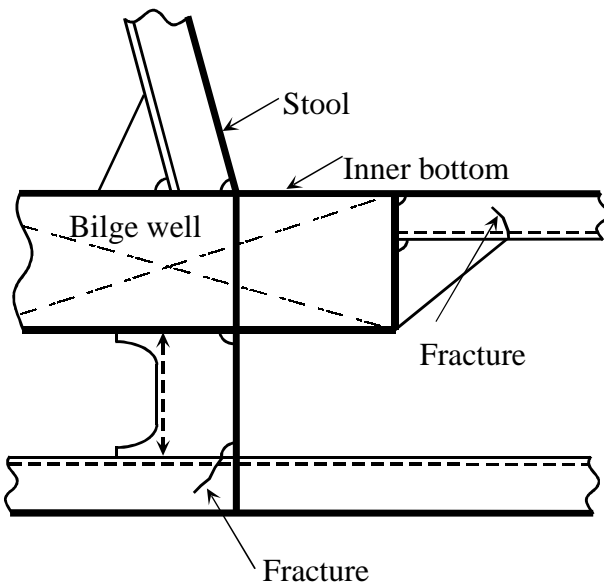
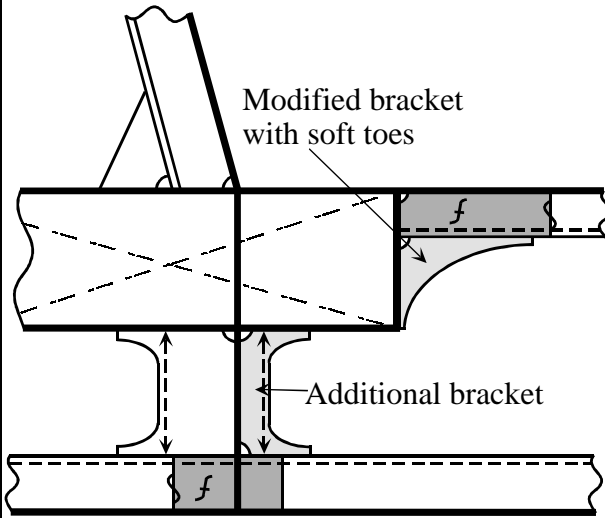
BULK CARRIERS		Guidelines for Surveys, Assessment and Repair of Hull Structure	
Part 1	Cargo hold region		Example No.
Area 5	Double bottom tank structure including hopper		9
Detail of damage		Fractures in longitudinal in way of bilge well	
Sketch of damage		Sketch of repair

<p>Labels: Stool, Inner bottom, Bilge well, Fracture, Fracture</p>

<p>Labels: Modified bracket with soft toes, Additional bracket, f</p> <p>f: Where required the longitudinals to be cropped and part renewed</p>	
Notes on possible cause of damage		Notes on repairs	
<p>1. Damage can be caused by stress concentrations leading to accelerated fatigue in this region.</p>		<p>1. If fractures are not extensive e.g. hairline fractures then these can be veed-out and welded.</p> <p>2. If the fracture extended to over one third of the depth of the longitudinal then crop and part renew.</p>
