**No.76 IACS Guidelines for Surveys, Assessment and
Repair of Hull Structure – Bulk Carriers**

BULK CARRIERS

**Guidelines for Surveys, Assessment and Repair of Hull
Structure**

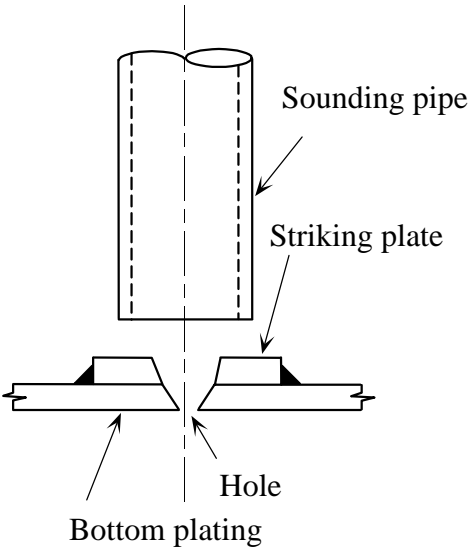
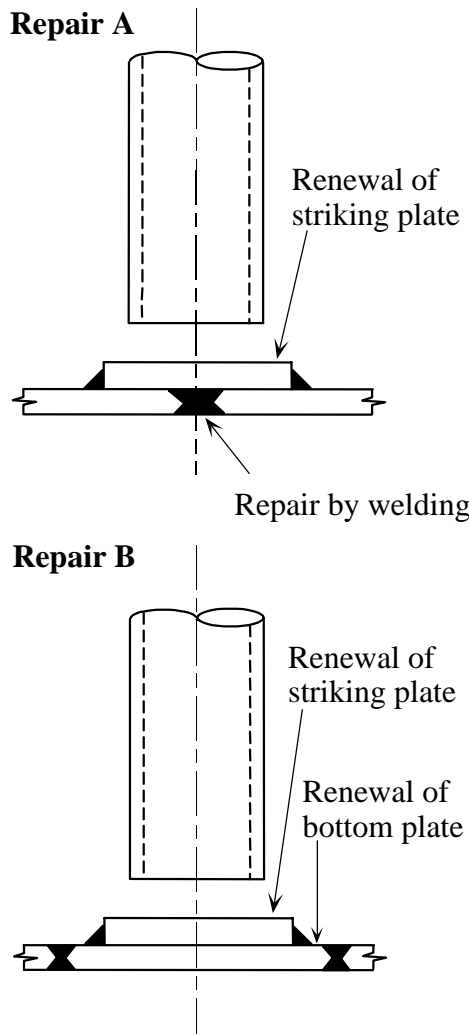
BULK CARRIERS		Guidelines for Surveys, Assessment and Repair of Hull Structure	
Part 1	Cargo hold region	Example No. 15	
Area 5	Double bottom tank structure including hopper		
Detail of damage		Corrosion in bottom plating below sounding pipe	
Sketch of damage		Sketch of repair

Notes on possible cause of damage		Notes on repairs	
<ol style="list-style-type: none"> 1. Accelerated corrosion of striking plate by the striking of the weight of the sounding tape. 		<ol style="list-style-type: none"> 1. Corroded bottom plating should be welded or partly cropped and renewed if considered necessary. 2. Corroded striking plate should be renewed.

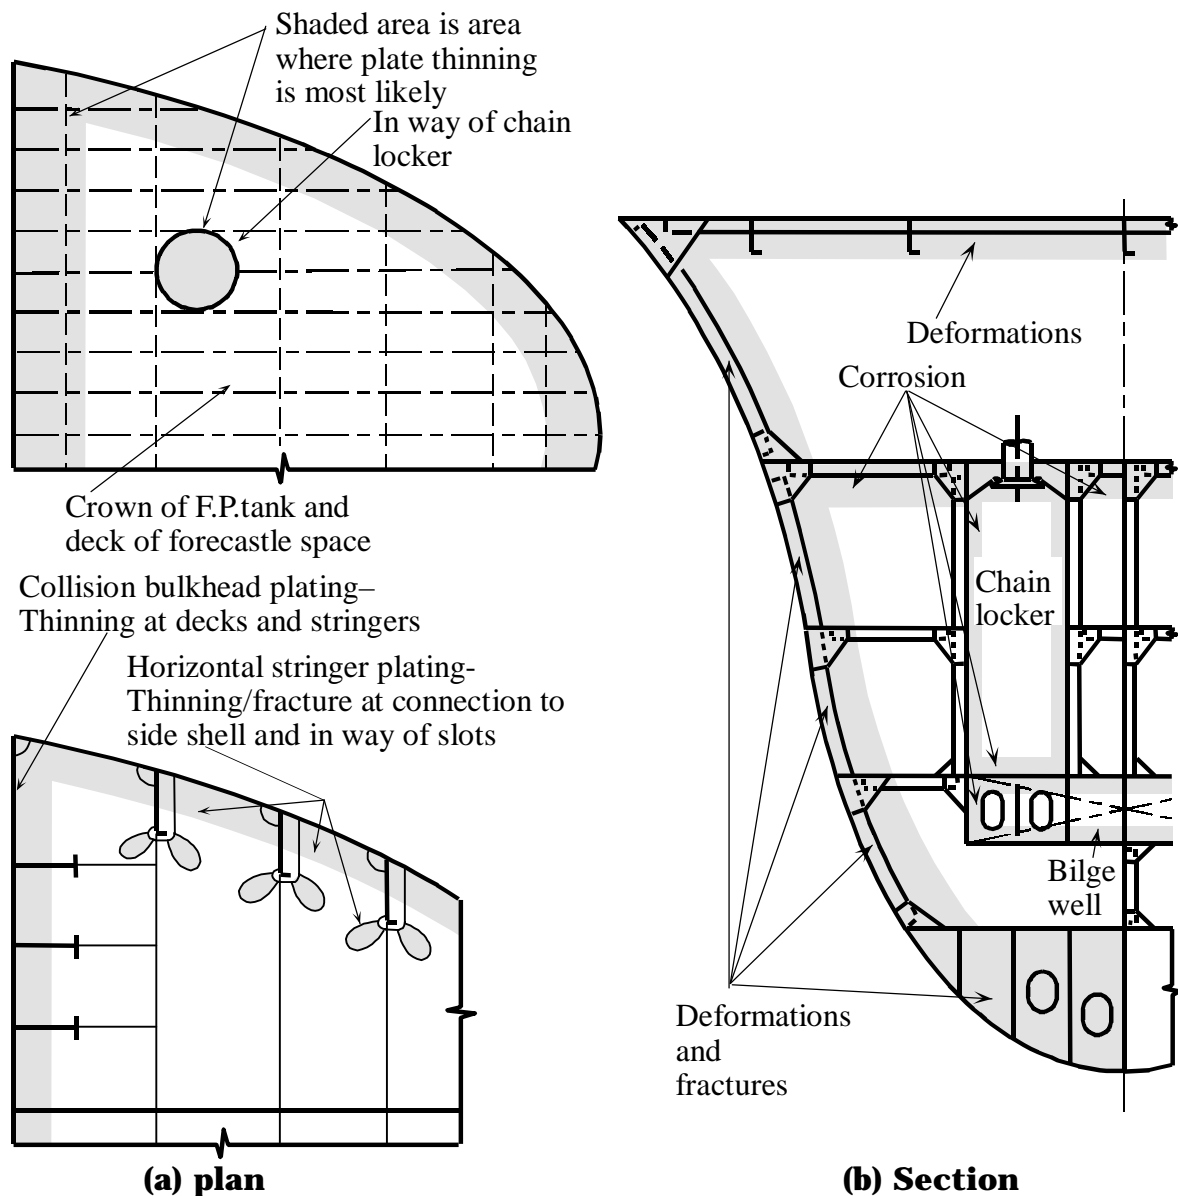
Fig 1 Fore end structure - Potential problem areas

- 2.1.1 Wastage (and possible subsequent fractures) is more likely to be initiated at the locations as indicated in **Figure 1** and particular attention should be given to these areas. A close-up inspection should be carried out with selection of representative thickness measurements to determine the extent of corrosion.
- 2.1.2 Structure in chain locker is liable to have heavy corrosion due to mechanical damage of ~~to~~ the protective coating caused by the action of anchor chains. In some ships, especially smaller ships, the side shell plating may form boundaries of the chain locker and heavy corrosion may consequently result in holes in the side shell plating.

- 2.3.1 Fractures in the fore peak tank are normally found by close-up inspection of the internal structure.
- 2.3.2 Fractures are often found in transition region and reference should be made to **Part 1, Area 2** and **3**.

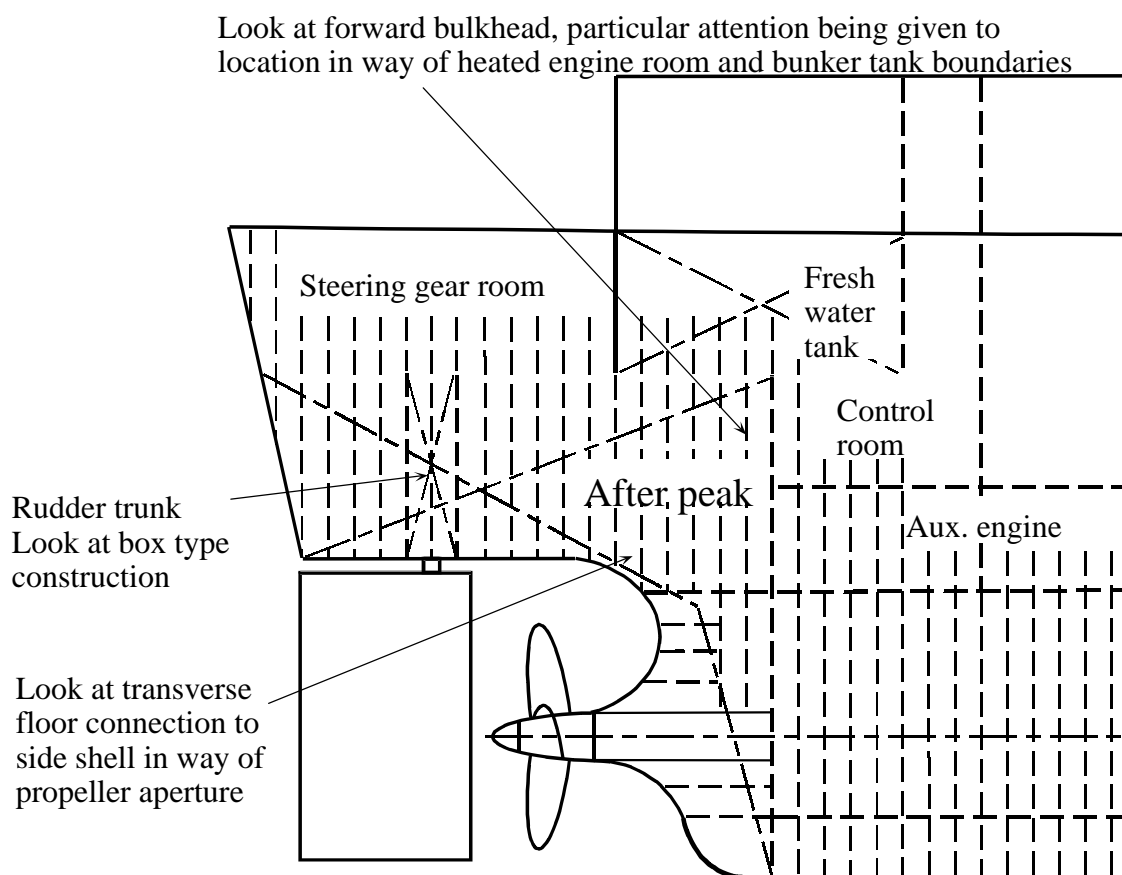
Figure 1 Aft end structure - Potential problem areas

- 2.3.1 Fractures in weld at floor connections and other locations in the aft peak tank and rudder trunk space can normally only be found by close-up inspection.
- 2.3.2 The structure supporting the rudder carrier may fracture and/or deform due to excessive load on the rudder. Bolts connecting the rudder carrier to the steering gear flat may also suffer damage under such load.

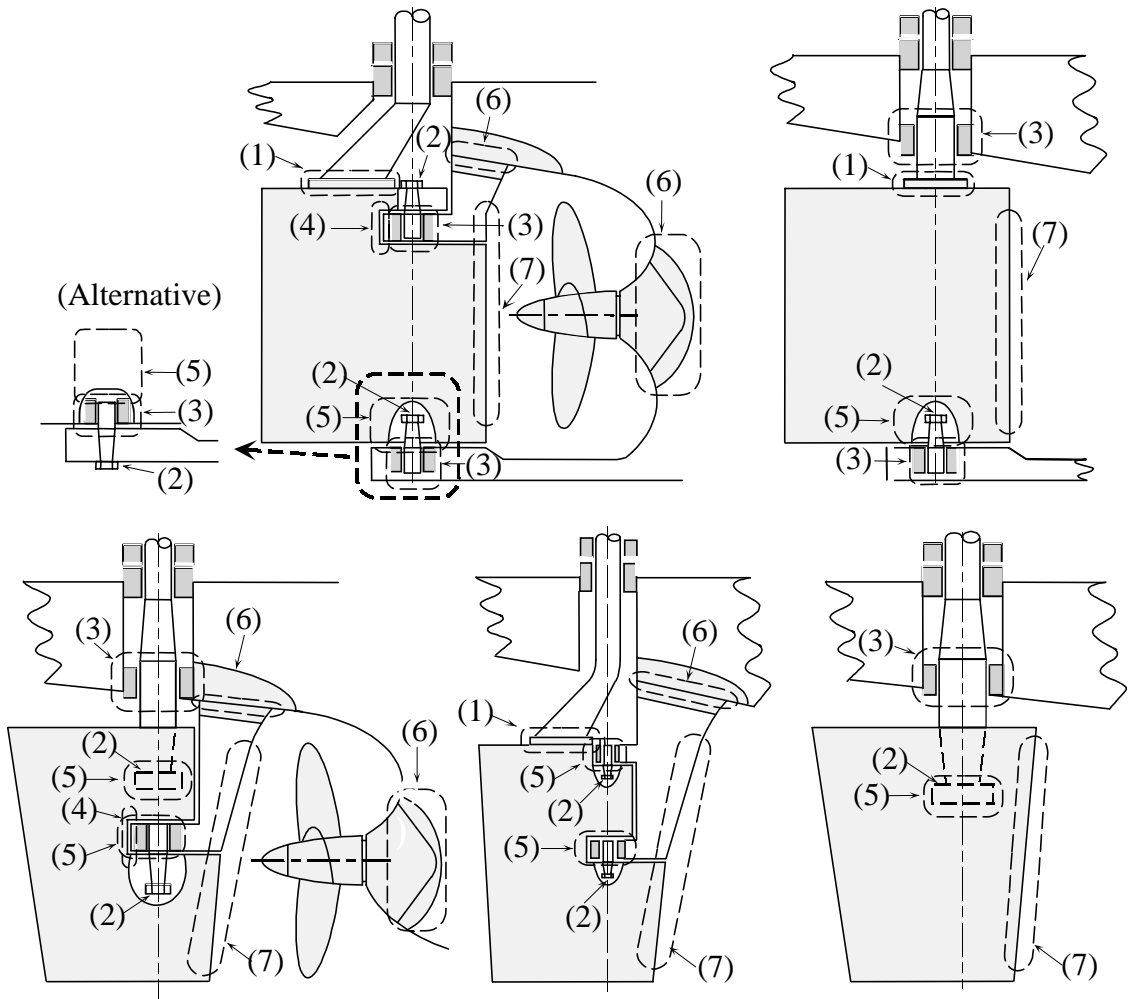
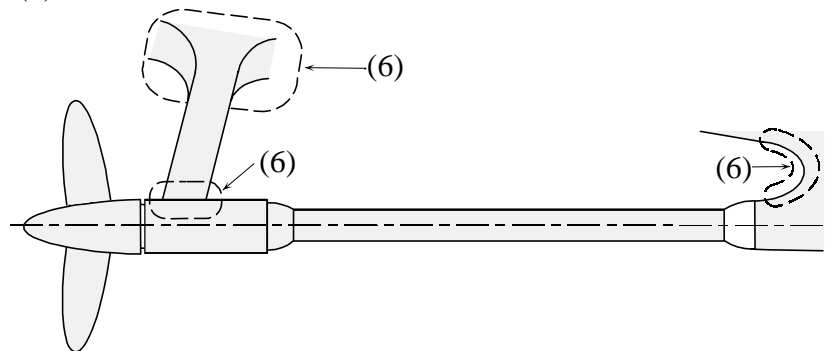
Figure 2 Potential problem areas

Damage to look for:

- (1) Fractures and loose coupling bolts
- (2) Loose nut
- (3) Wear (excessive bearing clearance)
- (4) Fractures in way of pintle cutout
- (5) Fractures in way of removable access plate
- (6) Fractures
- (7) Erosion

- 1.6** Pre-existing manufacturing internal defects in cast pieces may lead to fatigue cracking.
- 1.7** A summary of potential problem areas is shown in **Figure 2**.

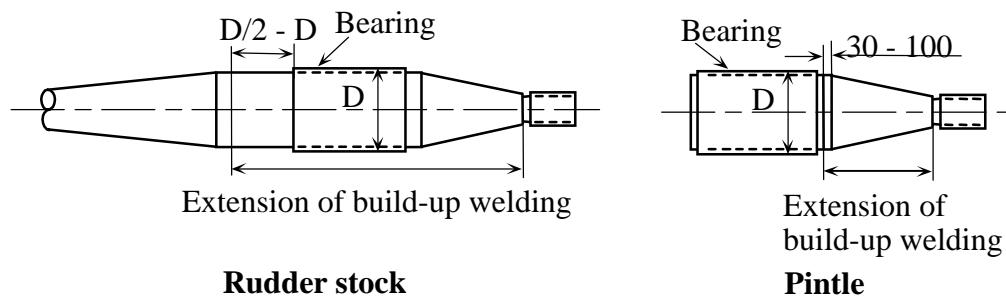
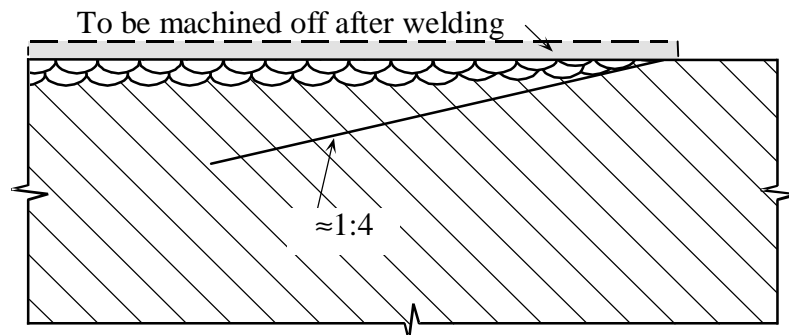
Figure 3 Rudder stock repair by welding

Replacing wasted material by similar ordinary weld material

- Removal of the wasted area by machining and/or grinding, non-destructive examination for fractures (magnetic particle inspection preferred)
- Build-up welding by automatic spiral welding (turning device) according to an approved welding procedure (weld process, preheating, welding consumables, etc.)
- Extension of build-up welding over the area of **large bending moments (shafts)** according to the sketch

- Sufficient number of weld layers to compensate removed material, at least one layer in excess (heat treatment of the remaining layer)
- Transition at the end of the build-up welding according to the following sketch

- Post weld heat treatment if required in special cases (never for stainless steel cladding on ordinary steel)
- Final machining, at least two layers of welding material have to remain on the rudder stock (See the above sketch)
- Non-destructive fracture examination

- 3.1.4** Rudder stocks and/or pintles may be repaired by welding replacing wasted material by similar weld material provided its chemical composition is suitable for welding, i.e. the carbon content must usually not exceed 0.25%. The welding procedures are to be identified in function of the carbon equivalent (Ceq). After removal of the wasted area (corrosion, scratches, etc.) by machining and/or grinding the build-up welding has to be carried out by an automatic spiral welding according to an approved welding procedure. The welding has to be extended over the area of large bending moments (rudder stocks). In special cases post weld heat treatment has to be carried out according to the requirements of the Classification Society. After final machining, a sufficient number of layers of welding material have to remain on the rudder stock/pintle. A summary of the most important steps and conditions of this repair is shown in the **Figure 3**.

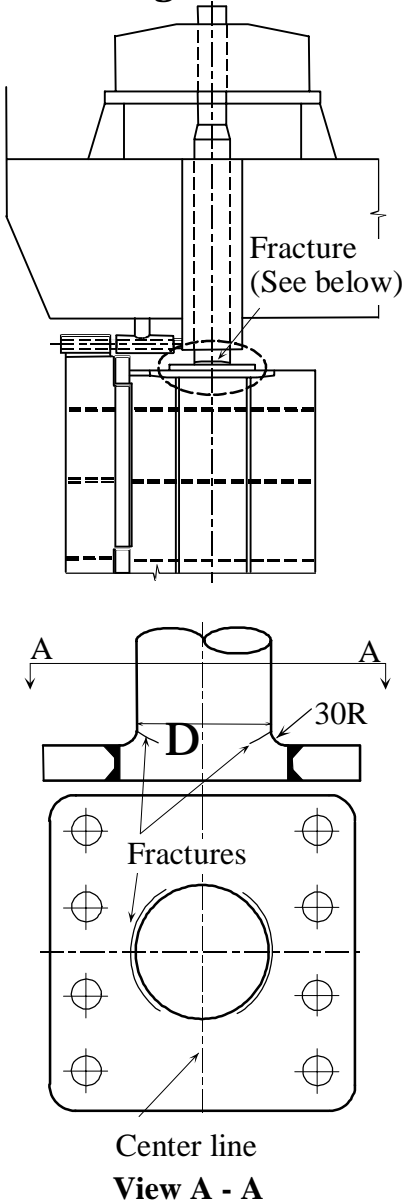
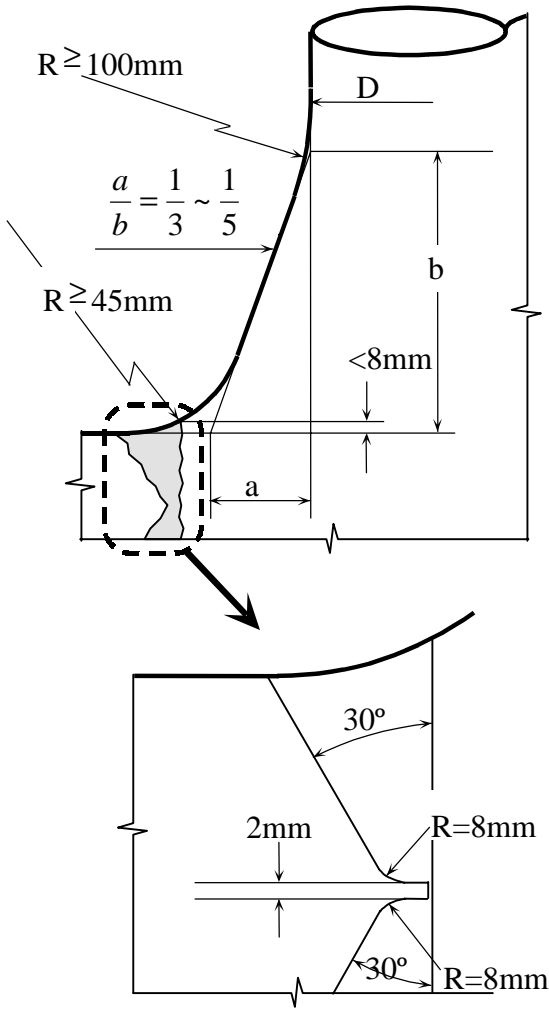
BULK CARRIERS	Guidelines for Surveys, Assessment and Repair of Hull Structure	
Part 2	Fore and aft end regions	Example No.
Area 3	Stern frame, rudder arrangement and propeller shaft support	2
Detail of damage Fractures in rudder stock		
<p>Sketch of damage</p>

<p>Fracture (See below)</p> <p>Center line View A - A</p>	<p>Sketch of repair</p>

<p>$R \geq 100\text{mm}$</p> <p>$\frac{a}{b} = \frac{1}{3} \sim \frac{1}{5}$</p> <p>$R \geq 45\text{mm}$</p> <p>$< 8\text{mm}$</p> <p>$30^\circ$</p> <p>$2\text{mm}$</p> <p>$R=8\text{mm}$</p> <p>$30^\circ$</p> <p>$R=8\text{mm}$</p>	
<p>Notes on possible cause of damage</p> <ol style="list-style-type: none"> Inadequate design for stress concentration in rudder stock. 	<p>Notes on repairs</p> <ol style="list-style-type: none"> Modification of detail design of rudder stock to reduce the stress concentration.

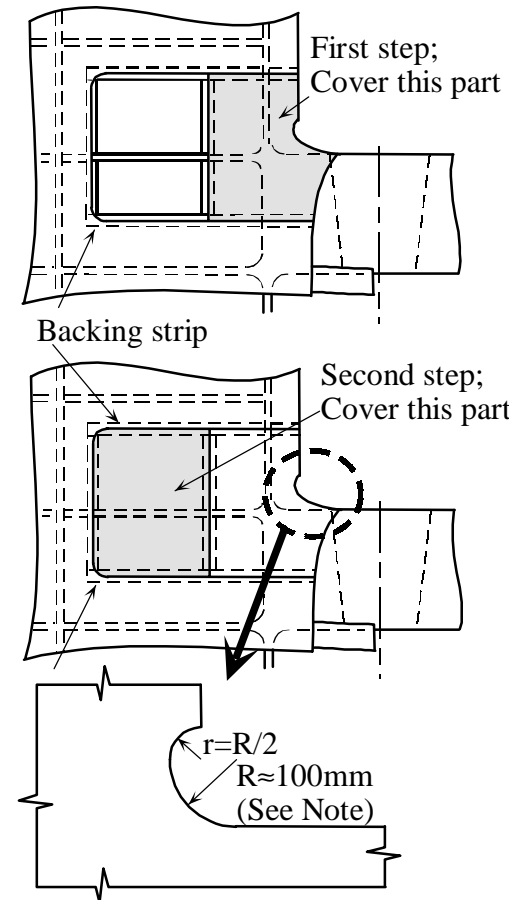
<p>Fracture in plate</p>

<p>First step; Cover this part</p> <p>Backing strip</p> <p>Second step; Cover this part</p> <p>$r=R/2$ $R\approx 100\text{mm}$ (See Note)</p> <p>Note: R should be considered according to local detail</p>	
Notes on possible cause of damage		Notes on repairs	
<ol style="list-style-type: none"> 1. Stress concentration due to inadequate local design and/or fabrication notches in way of the butt weld between cast piece and plating. 		<ol style="list-style-type: none"> 1. Fractured plating is to be cut-out. 2. Internal structures are to be checked. 3. Cut-out is to be closed by an insert plating according to the sketch (welding only from one side is demonstrated). 4. Modification of the radius. 5. In case of a new cast piece, connection with the plating is to be shifted outside the high stress area.

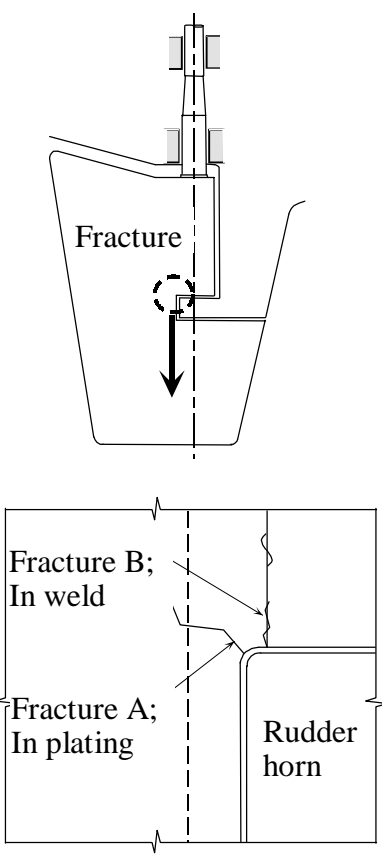
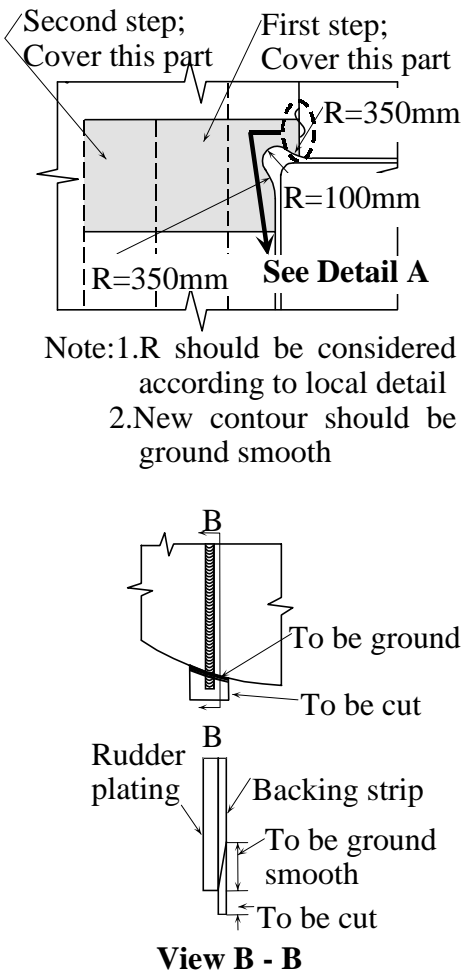
<p>The sketch of damage includes a perspective view of the rudder assembly with a dashed circle indicating a fracture in the plating. Below it is a cross-sectional detail showing 'Fracture B; In weld' and 'Fracture A; In plating' near the 'Rudder horn'.</p>

<p>The sketch of repair shows two steps: 'First step; Cover this part' with a radius of R=350mm and 'Second step; Cover this part' with a radius of R=100mm. A detail view shows the repair with 'Rudder plating', 'Backing strip', and areas 'To be ground smooth' and 'To be cut'. The detail is labeled 'View B - B'.</p> <p>Note: 1.R should be considered according to local detail 2.New contour should be ground smooth</p>

Notes on possible cause of damage		Notes on repairs	
<ol style="list-style-type: none"> Inadequate design for stress concentration in way of pintle bearing (Fracture A). Imperfection in welding seam (Fracture B). 		<ol style="list-style-type: none"> Fractured part to be cropped off. Repair by two insert plates of modified, stress releasing contour. For the vertical seam no backing strip is used 100mm off contour, welding from both sides, to be ground after welding. Variant (See Detail A): Repair as mentioned under 2 with the use of backing strip for the complete vertical seam. After welding backing strip partly removed by grinding.

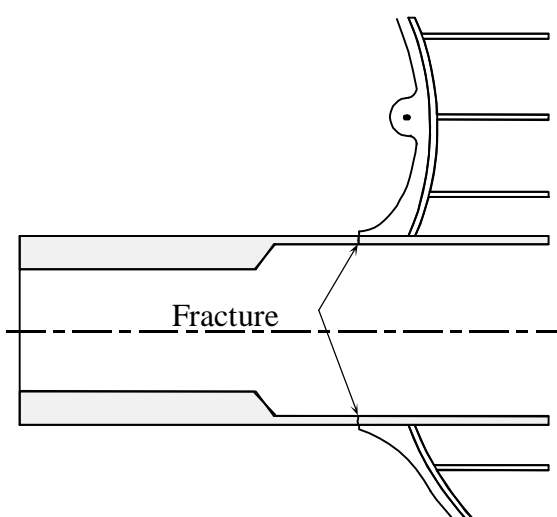
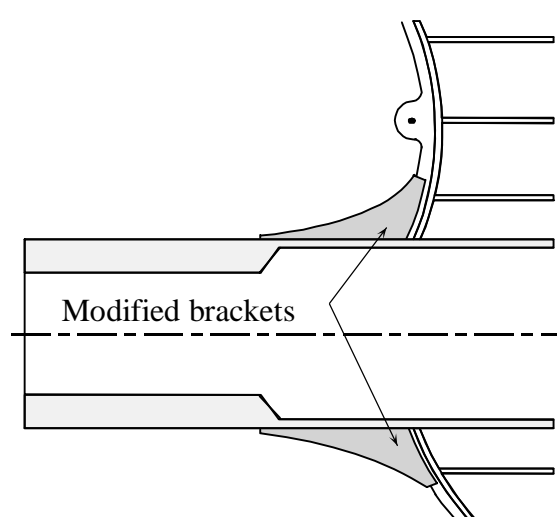
Notes on possible cause of damage		Notes on repairs	
<ol style="list-style-type: none"> 1. Fatigue fracture due to vibration. 		<ol style="list-style-type: none"> 1. Fractured tube is to be veed-out and welded from both sides. 2. Brackets are to be replaced by modified brackets with soft transition.
